JAPANESE PEARLERS' BATH-HOUSE, THURSDAY ISLAND, TORRES STRAIT

GORDON GRIMWADE

Grimwade, G. 2004 06 21: Japanese pearl-ers' bath-house, Thursday Island, Torres Strait. *Memoirs of the Queensland Museum, Cultural Heritage Series* 3(1): 379-386. Brisbane. ISSN 1440-4788.

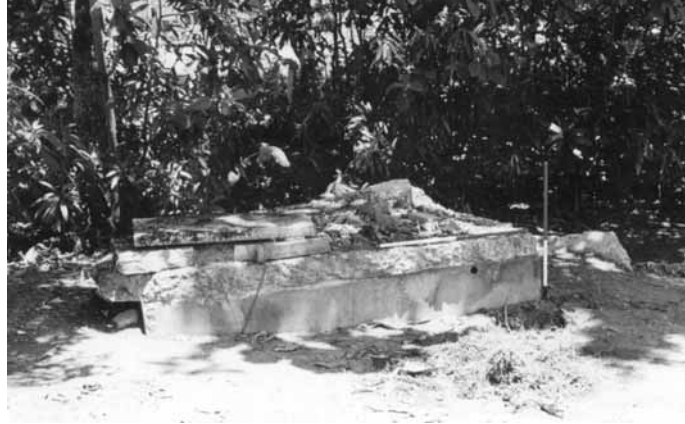
FIG. 2. Concrete block prior to archaeological work. View from near north western corner of house.

Assessment and excavation of the bath-house was severely constrained by an occupied house (containing 4 nuclear families) and a large external concrete slab extending some 15m beyond the rear of the flats. An excavation at the original site of the bath-houses was, clearly, a major undertaking and considered unlikely to reveal much significant data. An exploratory study noted several large pieces of concrete adjacent to the gully running across the lot (Fig. 2). One large concrete block, measuring 190 × 250cm, lay partially exposed near the bath-house site.

The profile exposed by excavation indicated fill extending adjacent to the concrete block. It was possibly associated with demolition of the bath-house (circa 1940s) or with site preparation for the construction of the adjacent Okinawan divers' boarding house (circa 1960). The concrete block extended to about 70cm below present ground level. Using the backhoe bucket it was inverted, primarily with the intention of removing it from the site. This action revealed a tile-lined bath.

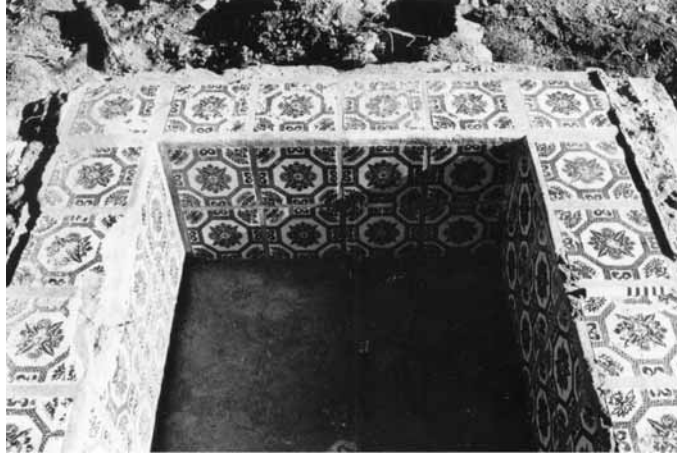
FIG. 4. Section of bath showing extent of concrete and tile placement.

exposed surfaces; such as the external wall. A finer plaster of concrete was then applied as a bedding for the tiles. This ranged from 3-5mm thick. The tiles were crudely embedded flush in concrete render (Fig. 4). The distance between tiles ranged from 16mm on one side wall (A-C) to 67mm on the top surface. Little effort was made to square the tiles with each other. The gap between 2 of the horizontal surface tiles was 62-67mm and 31-35mm between 2 other tiles. The most accurately placed tiles were parallel with a 32mm gap. On one end wall (C-D) the space between top and bottom rows diverged by 5mm, from 15-20mm. On wall A-C the spacing between the rows diverged from 12-20mm. Sixty-eight tiles are incorporated in the recovered section of the bath.

The practice of embedding the tiles in the wall render differs markedly from modern practices in Australia and Japan where the surface is first plastered and each tile is butt joined and filled in between with 'grout'. It is possible that makers of the bath-house quickly recognised that

insufficient tiles were available to undertake a standard butt joining with the adjacent tiles. Spreading the tiles, to provide some overall balance to the bath, was a logical solution. In this case, the 'grout' was part of the rendering. From close visual examination it appears that a thin render was applied initially for tile support. The in-fill cement render was added later.
